# A HIDDEN LEAK. TSA DIRECTLY BELOW. ONE ACCOUNTABLE TEAM.

A persistent leak beneath Delta lounge showers required more than another service visit. ASI connected investigation, controlled demolition and specialist repair inside a restricted airport environment.

## DELTA AIR LINES | LOS ANGELES INTERNATIONAL

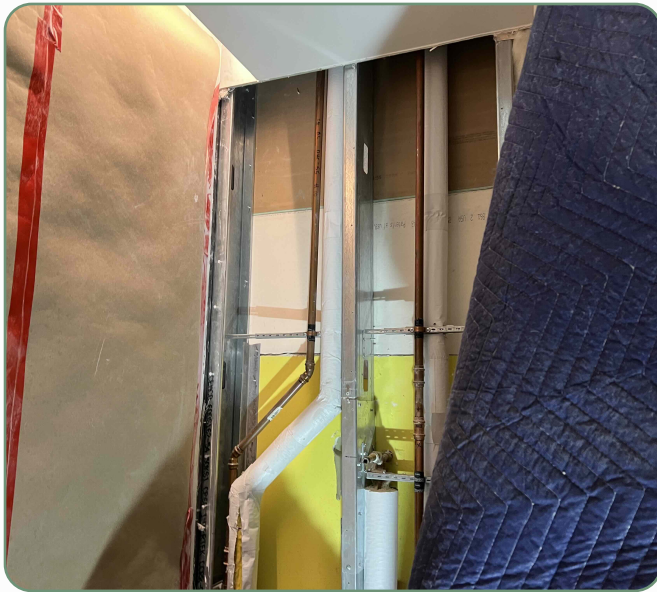
**PROTECTED WALL OPENING**

Retained finishes protected as access was created.

Selective removal of tile and backing opened the required wall area, connecting the investigation to physical access for the repair.

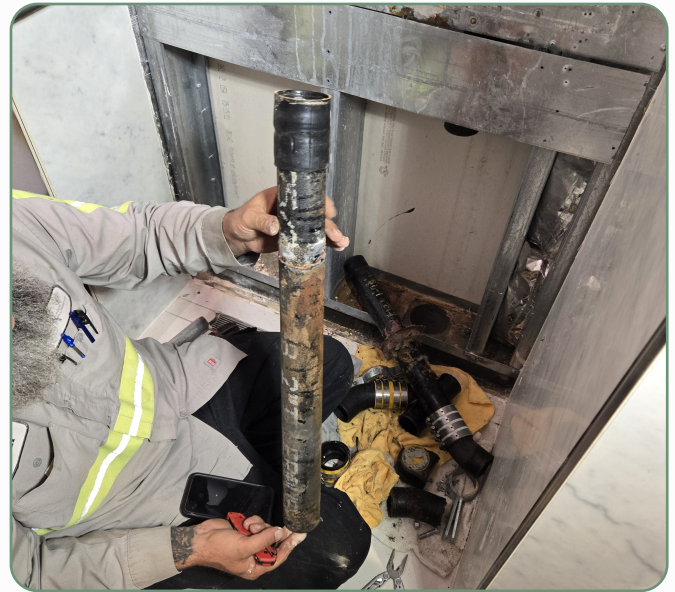
**CONCEALED PIPE REPLACEMENT**

Targeted removal inside the opened wall.

The team replaced the leaking cold-water section and affected cast-iron vent piping, with supports and sealed floor penetrations.
