# COMPLEX SYSTEMS. CONTROLLED REMOVAL. ONE ACCOUNTABLE TEAM.

ASI connected cooling removal, electrical safe-off, fire-system coordination and building restoration in a compressed technical decommissioning program for HCLTech in Cary.

## HCLTECH | CARY, NORTH CAROLINA

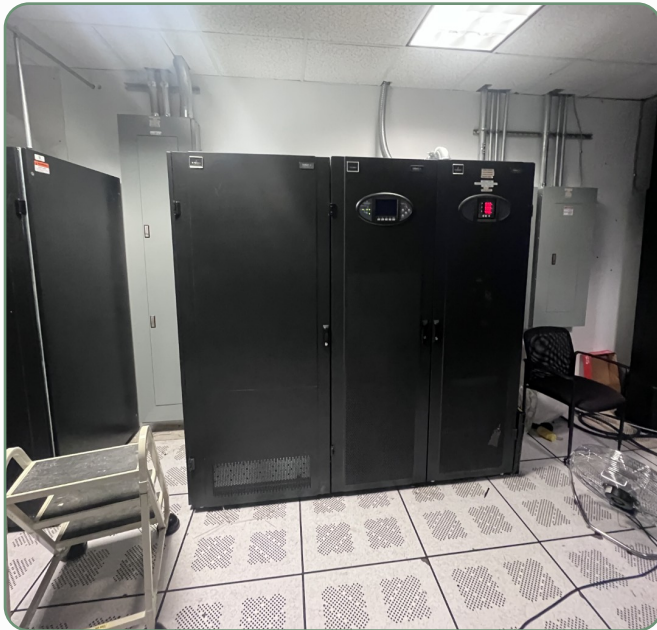
**COOLING EQUIPMENT | PRE-REMOVAL**

Remove two water-cooled Liebert PCW units, associated drains and approximately 600 linear feet of chilled-water piping back toward the mechanical room.

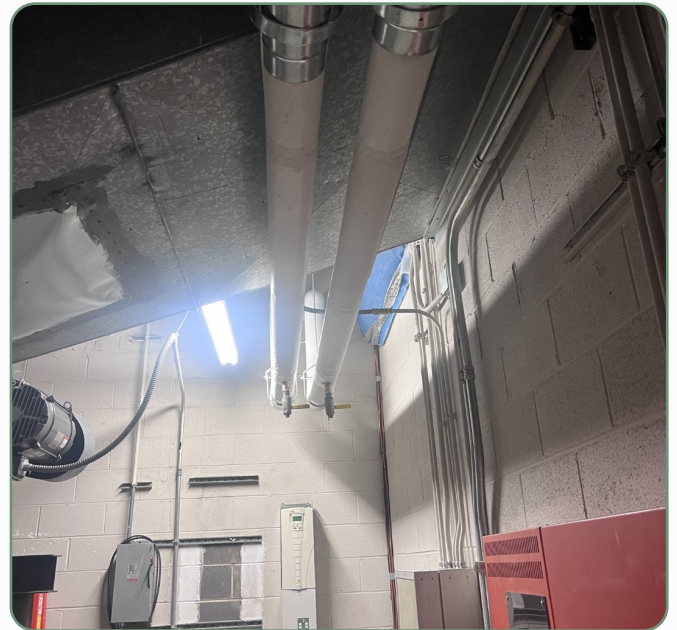
**CHILLED-WATER ROUTE | PRE-REMOVAL**

Removal extended from the server room toward the mechanical room.

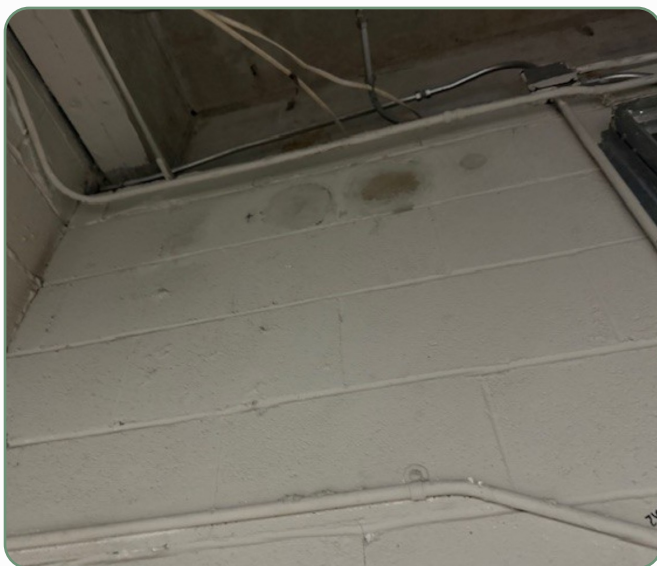
**PIPE-ROUTE REPAIR | IN PROGRESS**

Repair the affected hard-lid and pipe-route areas. Coordinate access through adjoining spaces with the building engineer, including a planned two-day restroom shutdown.

Repair work followed the piping removal through affected hard-lid areas.

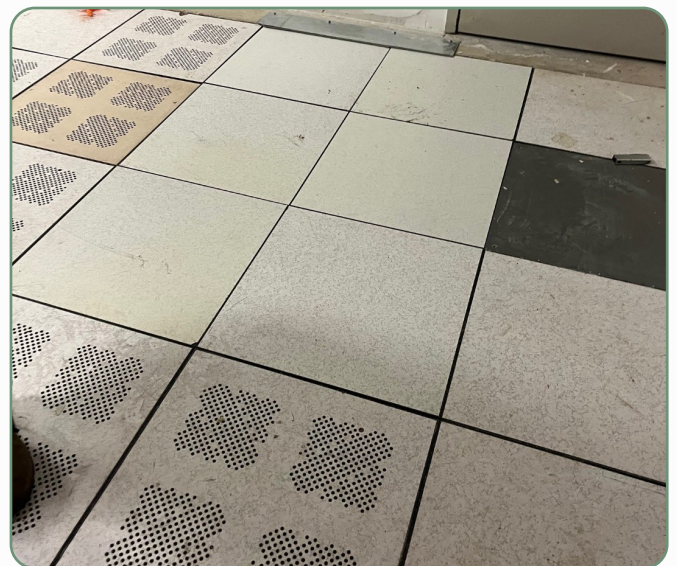
**RAISED-FLOOR INFILL | COMPLETED**

Handle in-room low-voltage and card-system removal, then add raised-floor infill using existing material as the follow-on authorized flooring scope.

Affected hard-lid and route repairs followed removal. The later raised-floor infill reused existing material.
